Metals in America's Historic Buildings

Uses and Preservation Treatments

Part I. A Historical Survey of Metals

Part II. Deterioration and Methods of Preserving Metals

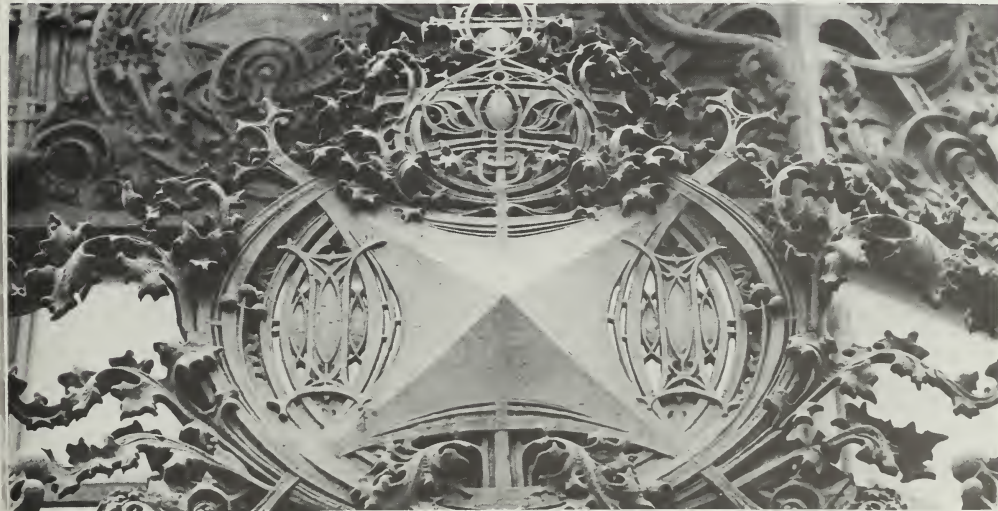
Figure 1. Cast-iron Ornamentation, Carson Pirie Scott and Company Store, Madison and State streets, Chicago, Illinois, 1899-1906; Louis H. Sullivan, architect; Winslow Brothers, foundry. The two lower floors of this building are embellished by Sullivan's extraordinarily complex designs executed in cast iron which enframe the windows and curved corner entrance. Cast iron was used in every conceivable form in the 19th century; it was the utilitarian metal. Cast-iron columns, storefronts, whole building facades, and stairs appeared, as did cast-iron doors, windows, clocks, fountains, and furniture. What could not be made of cast iron was made of wrought iron or steel. Beams were made of wrought iron or steel, and metal ceilings and roofs were made of sheet iron or steel. Often ironworkers combined cast iron and wrought iron in a design, using each metal for the elements for which it was best suited. (Becket Logan)

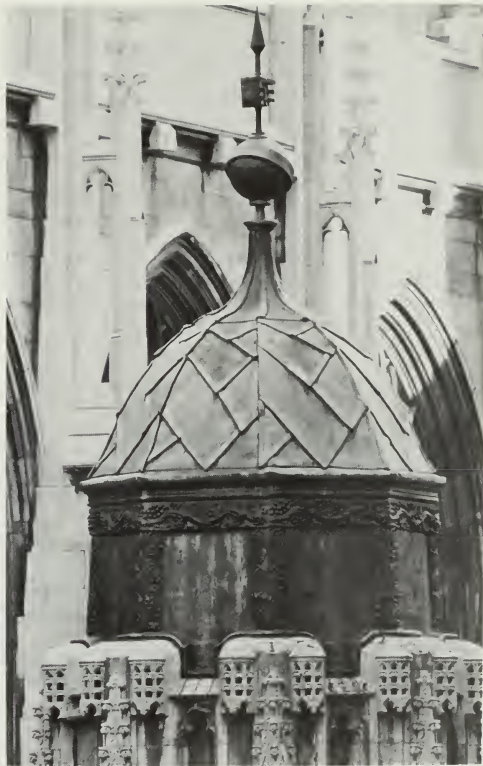
Figure 6. Lead Roofing, Saint Thomas Church, Fifth Avenue and 53rd Street, New York City, 1909–1914; Cram, Goodhue, and Ferguson, architects; Henry Hope and Sons, lead craftsman. Ralph Adams Cram designed St. Thomas Church using the spirit and many of the techniques of medieval builders, including the use of small overlapping sheets of lead for roofing curved surfaces. The decorative grapevine frieze and panel borders, also of lead, show the versatility of this material, which can be cast with sharp detail. (Becket Logan)

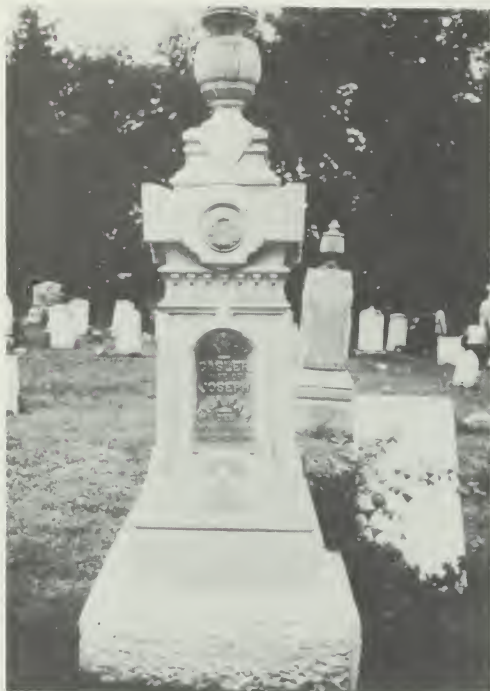
Figure 14. Zinc Grave Marker, Herkimer, New York, ca.1874; Monumental Bronze Co., Bridgeport, Connecticut. The manufacturer's name is discreetly recorded in small letters along the edge of the plinth. This company's 1882 catalog used the phrase "pure cast zinc" while insisting that "unlike commercial zinc ours is a pure metal, like gold or silver." The embossed epitaph is still crisp and new looking. In some respects the zinc monuments have survived in better condition than their stone counterparts. These light gray markers were cast in many sections, sandblasted to produce a rough stone-like surface, then bolted together with the connections disguised. (Margot Gayle)

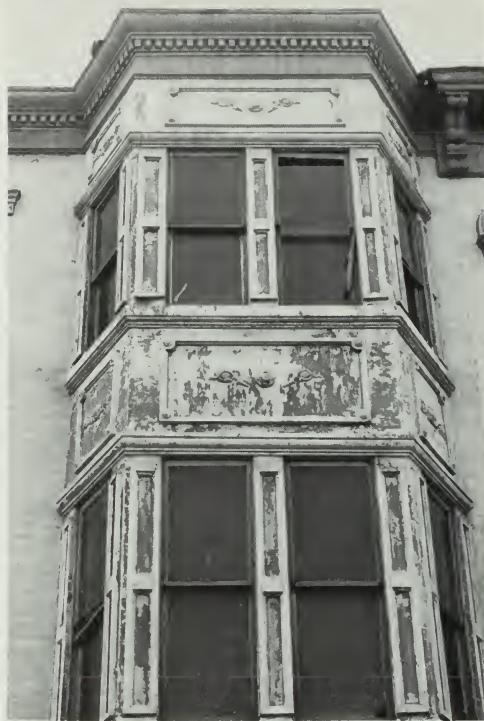
Figure 18. Galvanized Sheet Iron Bay with Applied Zinc Ornament, 608 Indiana Avenue, NW, Washington D.C. When sheet metal work is kept well painted, it is very difficult to identify it as sheet iron or steel, galvanized or tinplated. However, if the metal is not maintained, its composition becomes more obvious. Paint does not adhere well to pure zinc, or to galvanized iron or steel. When the paint peels, it usually comes off completely, including the primer, to reveal a clean metal surface. If the metal is galvanized, it will have a spangled appearance and may show some rust or rust stains from the iron base metal. If it is cast or pressed zinc, it will have a grayish-white appearance. This bay is covered with galvanized sheet iron with pure zinc ornaments on the surface. Even if well painted, a magnet test will reveal what is galvanized iron or steel (which is magnetic) and what is pure zinc (which is non-magnetic). (David W. Look)

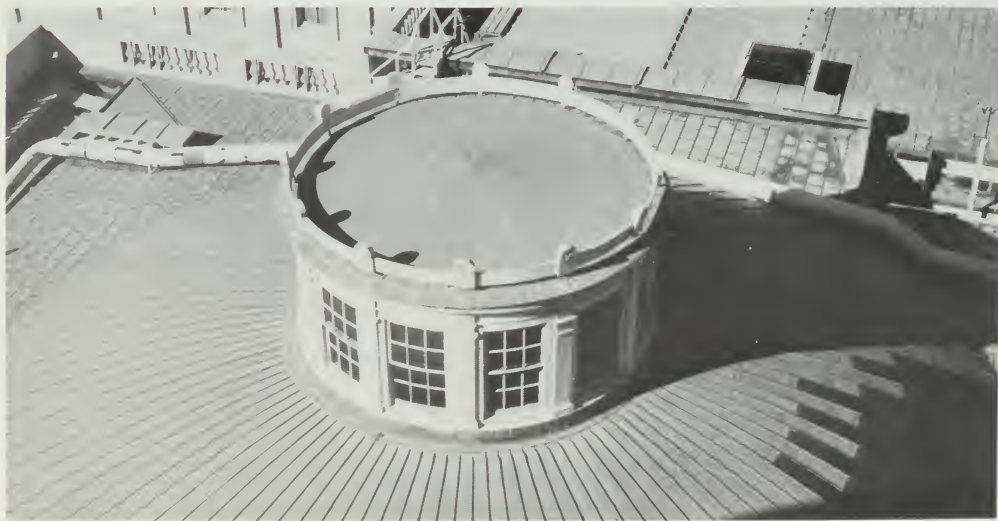
Figure 19. Copper Roof, Old Senate Chamber, United States Capitol, 1819; Benjamin H. Labrobe, architect. After the British burned the Capitol in 1814, the entire structure was rebuilt, including a new copper roof. Little is known about the roofing installed in 1819 since it was removed in 1900. It was probably all flat seams because the machine for forming standing seam roofing was not invented until about the time of the Civil War. When the surfaces were reroofed in 1975, every effort was made to duplicate the 1900 roofing patterns, configuration, and size of sheets. Sheet copper can be shaped to cover many types of curved surfaces. The dome has standing seams while the cupola and the area around the dome, which is flatter, have flat seams. (Charles Parrott)

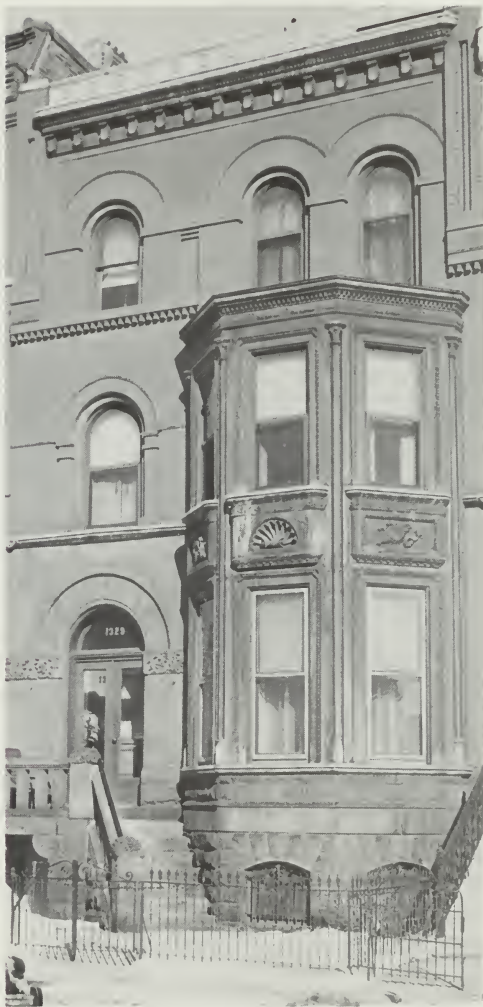
Figure 24. Copper-Clad Bay Window and Cornice, Thomas C. Whyte House, 1329 R Street, NW, Washington, D.C., 1892; George C. Johnson, architect. From the first-floor window sills to the cornice above the second floor, the bay window is sheathed entirely with pressed sheets of copper, and there are slender two-story copper pilasters flanking the windows. The spandrel between the first- and second-floor center windows has a shell design and the side spandrels have winged sea creatures. Both the cornice of the house and the cornice of the bay window have copper classical dentils and modillions. (David W. Look)

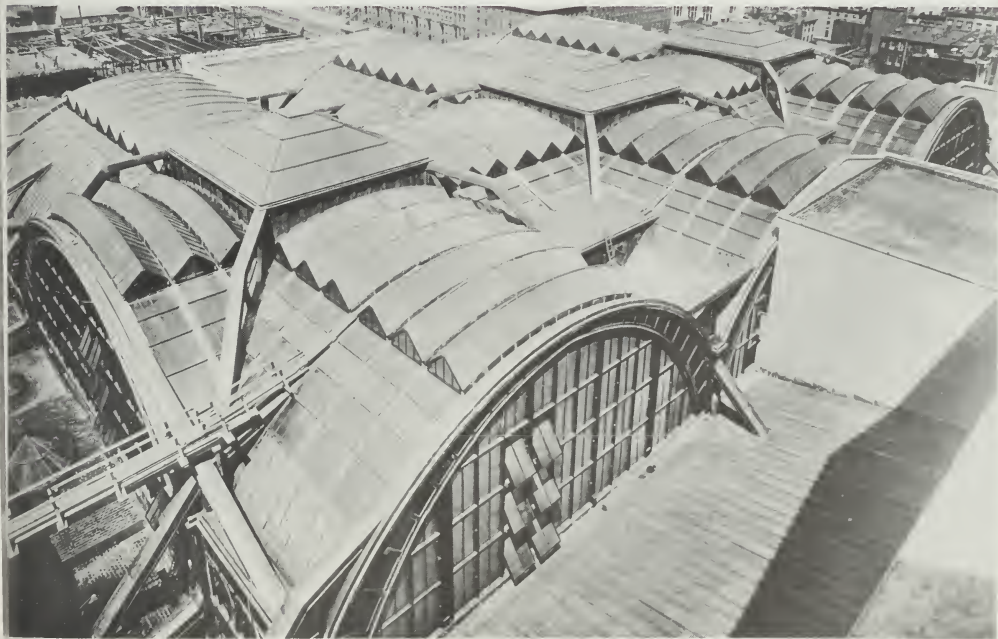
Figure 47. Monel Roof, Pennsylvania Railroad Terminal, New York City, 1907-1910; McKim, Mead and White, architects; International Nickel Company. The first architectural use of Monel metal was the sheet roofing of the Pennsylvania Station, which was completed in 1909. When the station was demolished in 1965, the Monel roof was in excellent condition, having needed no major repairs since its installation. (International Nickel Company)

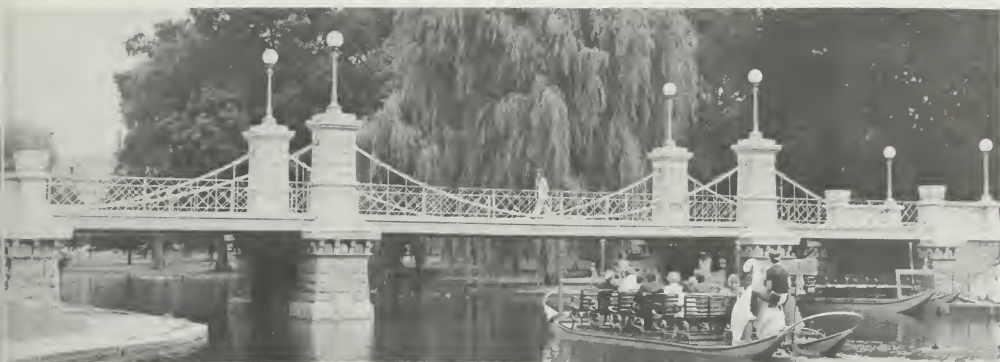
Figure 61. Suspension Bridge, Public Garden, Boston, Massachusetts, 1867; Elemens Herschel and William Preston, engineers. Popular among Bostonians, this small suspension bridge originally consisted of plank flooring hung from chains made of flat wrought-iron links. In 1921 the bridge's deteriorated wood was replaced with steel beams; the bridge was reinforced in 1975 with more steel and concrete. Although the deck has been replaced, the masonry piers and the chains hung between them are still largely original. (Carleton Knight, III)

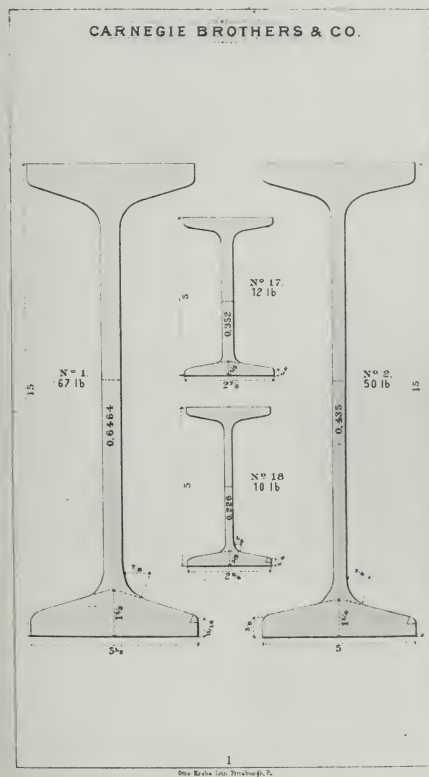
Figure 62. Wrought-iron Beams, Carnegie Brothers and Company's Pocket Companion . . . , 1876. The earliest known wrought-iron handbook of wrought iron structural shapes was published by Carnegie Kroman and Co. in 1873, some 18 years after the first wrought-iron I-beams were rolled in the United States by the Trenton Iron Works, founded by Peter Cooper. Copies of the 1873 handbook are quite rare; however, the Library of Congress has a copy of the 1876 handbook of Carnegie Brothers and Co. The Iron and Steel Beams: 1873 to 1952, published by the American Institute of Steel Construction, Inc., is a valuable resource book because it documents the handbook dates, the sizes, weights, and properties of all rolled beams during this period. The largest beam in the 1873 handbook was 15 inches deep and 67 pounds per lineal foot, the same as the beam shown in this illustration at the far left. (Library of Congress)

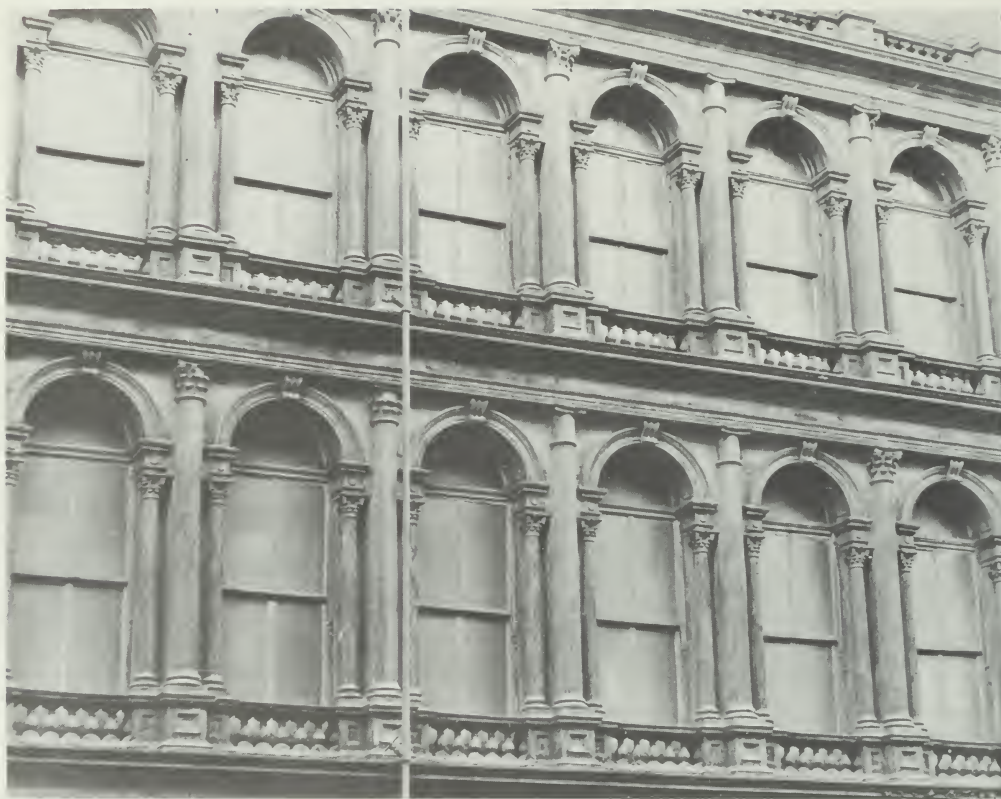
Figure 65. Cast-iron Haughwout Building, 490 Broadway, New York City, 1856; John P. Gaynor, architect; Daniel D. Badger's Architectural Iron Works of New York City. Some of the best iron front buildings stand in the SoHo area of the city. There are excellent examples of the quality and character of mass-produced 19th-century ironwork. Once foundry patterns were prepared, any number of like building fronts could be cast. The facade of the Haughwout Building consists of a single module, Palladian in character, repeated again and again. The result was an impressive design at a moderate cost. (Clover Vail)

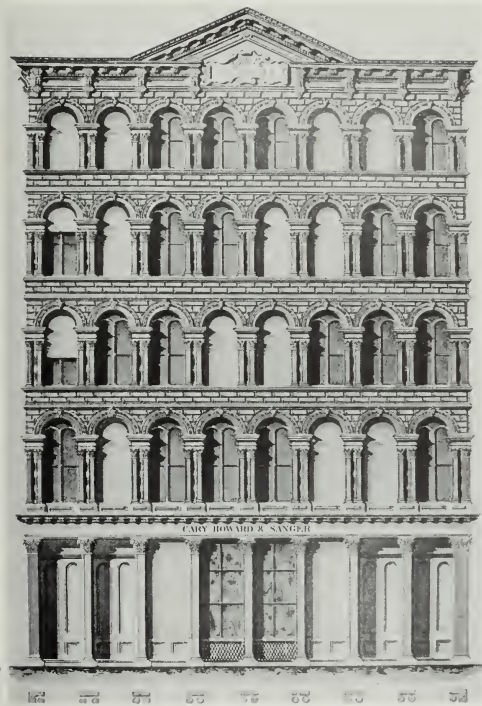
Figure 66. Catalog Illustration, Cary Building, New York City, 1856; John Kellum, architect; Daniel D. Badger's Architectural Iron Works of New York City. This iron front design depicted in the 1865 catalog of Badger's foundry is still standing in downtown Manhattan. Although the iron is scored to look like ashlar, the slender freestanding colonettes between the windows reveal that the facade is metal, not stone. Many of the rolling metal shutters at the windows have been pulled shut. Badger sold rolled iron shutters before he started promoting cast-iron storefronts. (Avery Library, Columbia University)

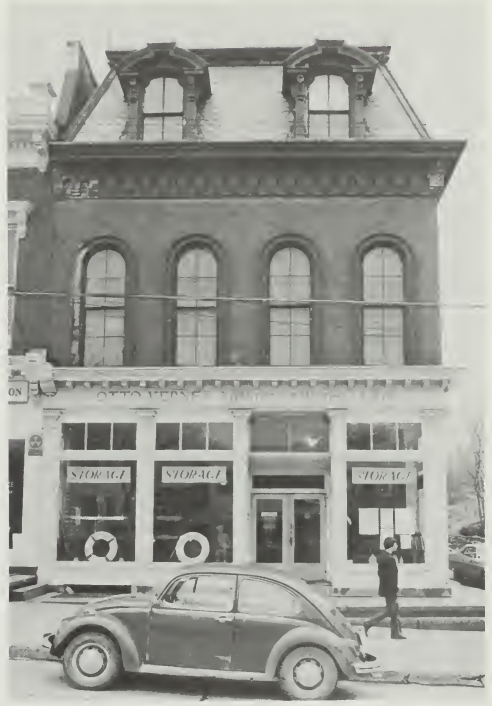
Figure 67. One-story Cast-iron Storefront, 75 Main Street, Cold Spring, New York. This modest facade is typical of cast-iron storefronts popular for decades after their introduction about 1825. Fabricated by both small local foundries and large nationally known companies, storefronts were available in a variety of styles and sizes, and could be ordered from catalogs. The slender piers and columns could support the weight of several stories, usually masonry, while providing the framework for broad expanses of glass. The open front was perfect for the display of merchandise. (Otto Verne)

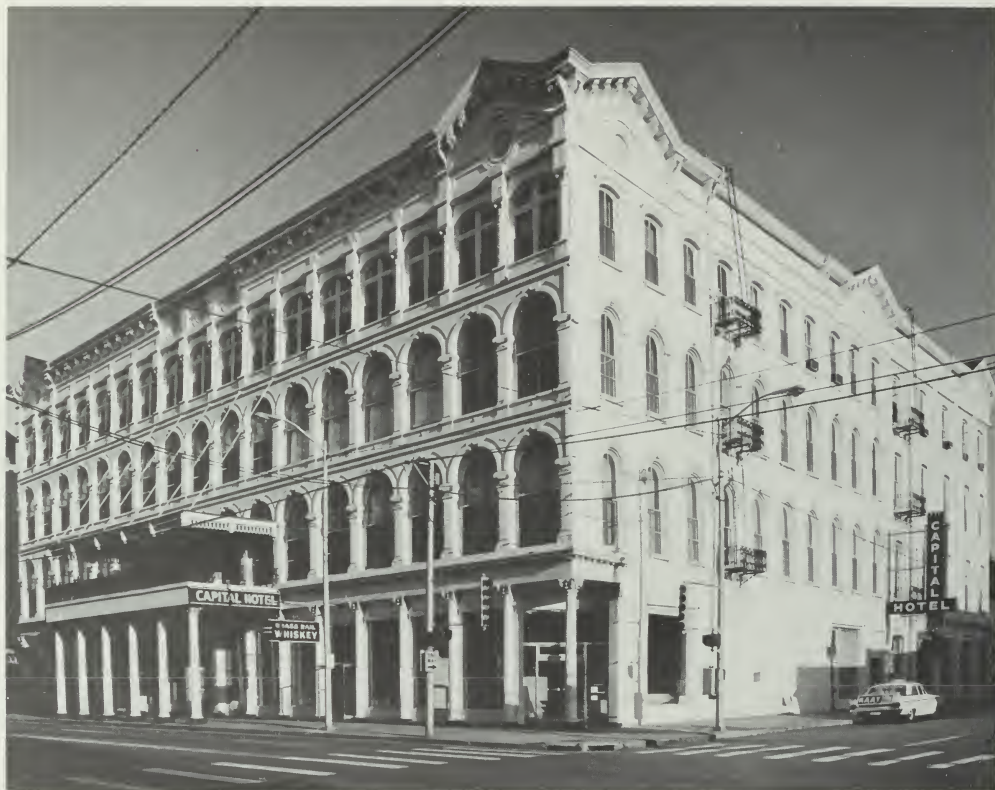
Figure 68. Cast-iron Facade, Capital Hotel (originally the Denkla Office Building), 117 West Markham Street, Little Rock, Arkansas, 1873. The Italianate office building was converted in 1877 into a hotel. Being located near the state capitol, it became popular with politicians and was often used as campaign headquarters. Note the difference in window size in the facade and the masonry sidewall. The larger windows of the cast-iron front provided a great deal of natural light, which the building's original use (offices) required. Although not apparent from a distance, the top story of the front facade and the cornice are pressed sheet metal, probably galvanized iron. (Earl Saunders)

The skillful application of lead and glass in doorway fanlights and sidelights appeared in some late Georgian and many Federal houses. Later, during the Victorian era, stained-glass windows, doors, and decorative skylights became fashionable for public buildings and residences as well as for churches. The stained-glass skylight in the Capital Hotel in Little Rock, Arkansas, is a good example of this (figure 8).

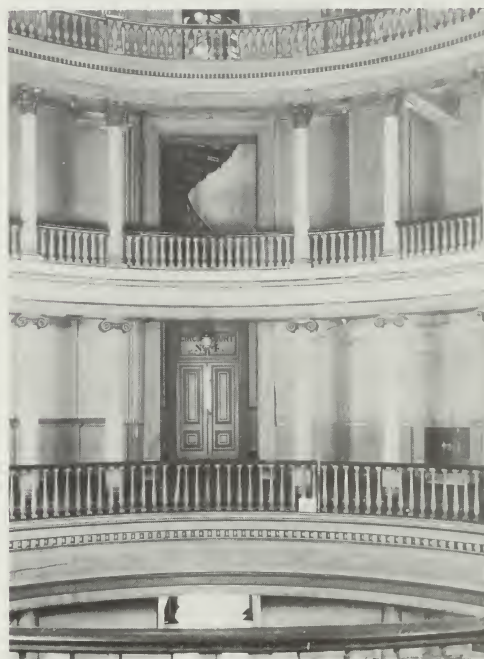
Figure 73. Rotunda Galleries, Old St. Louis Courthouse, Fourth and Market Streets, St. Louis, Missouri, 1859 expansion; William Rumbold, architect. The courthouse has many iron elements, including the intricate elliptical cast-iron staircases in the wings and half of the Ionic and Corinthian columns which support the rotunda galleries. Every other column is wood. The cast-iron columns were added to take the increased load of the dome, a major feat of engineering and architectural design. William Rumbold accomplished the detailed engineering of the dome between 1859 and 1862, one and one-half years before the dome of the U.S. Capitol was completed. (Piaget, NAER)

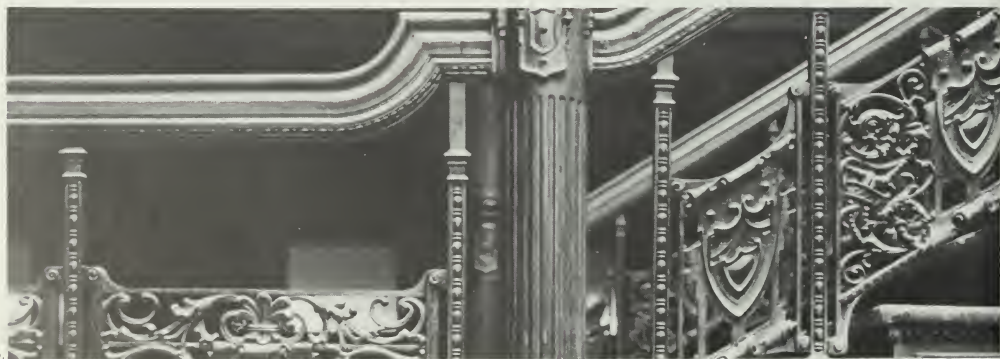
Figure 80. Light Court and Detail of Cast Iron Stairs, Bradbury Building, 304 Broadway, Los Angeles, California, 1893; George Wyman, architect; Winslow Brothers, foundry, Chicago, Illinois. (a) Built for the successful miner Louis Bradbury, this conventional masonry building gives no hint from the outside of its remarkable interior light court with its iron and glass skylight. The five-story open space has bird-cage-like elevators moving in open shafts with the machinery and counterweights exposed. (b) The elaborate openwork design of the galleries was cast in bold relief on both sides of the panels. The railings were cast in many parts and then assembled. Slender beaded balusters take the form of clawed feet where they attach to the staircase. All parts of the railing and galleries are outstanding examples of the art of sandcasting. (Becket Logan)

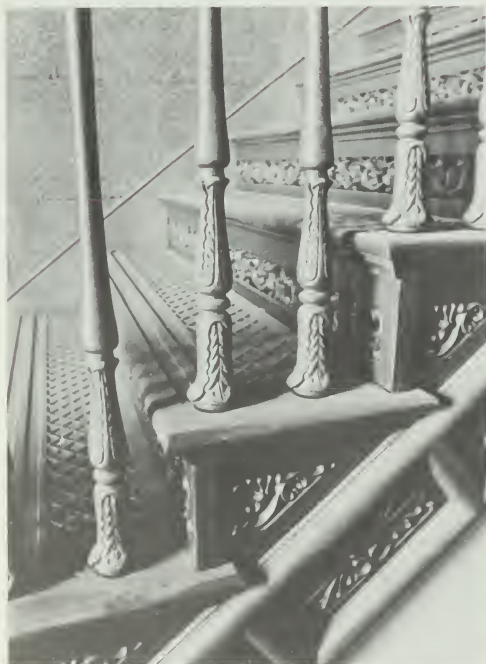
Figure 81. Restored Cast-iron Stairs, Old Customs House (now known as West Virginia Independence Hall), Wheeling, West Virginia, 1859; Ammi B. Young, Architect of the Treasury. In this building the people of western Virginia declared their independence during the Civil War and joined the Union. These cast-iron stairs and balusters have recently been restored with the recasting of missing or damaged pieces. Perforated stairs were originally designed to combine decorative, functional, and economical detailing; to provide elaborate but strong construction; and to reduce the weight and quantity of iron required. (West Virginia Independence Hall Foundation)

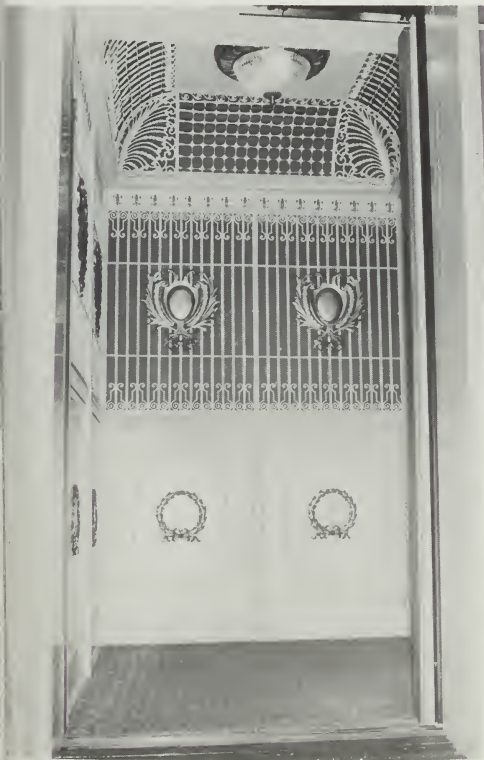
Figure 83. Cast-iron Elevator Cab, Otis Elevator Company, 1905; Pioneer Courthouse (U.S. Courthouse and Customhouse), 520 Southwest Morrison Street, Portland, Oregon, 1869-1873. To meet fire code requirements, restoration architects McMath and Hawkins installed a new fire wall inside the elevator shaft in 1973. To give the illusion of openness, the elevator grille and cab were painted a cream color, with gilt shields and wreaths; the fire wall was painted a dark gray, creating the effect of a silhouette. (Mike Henley)

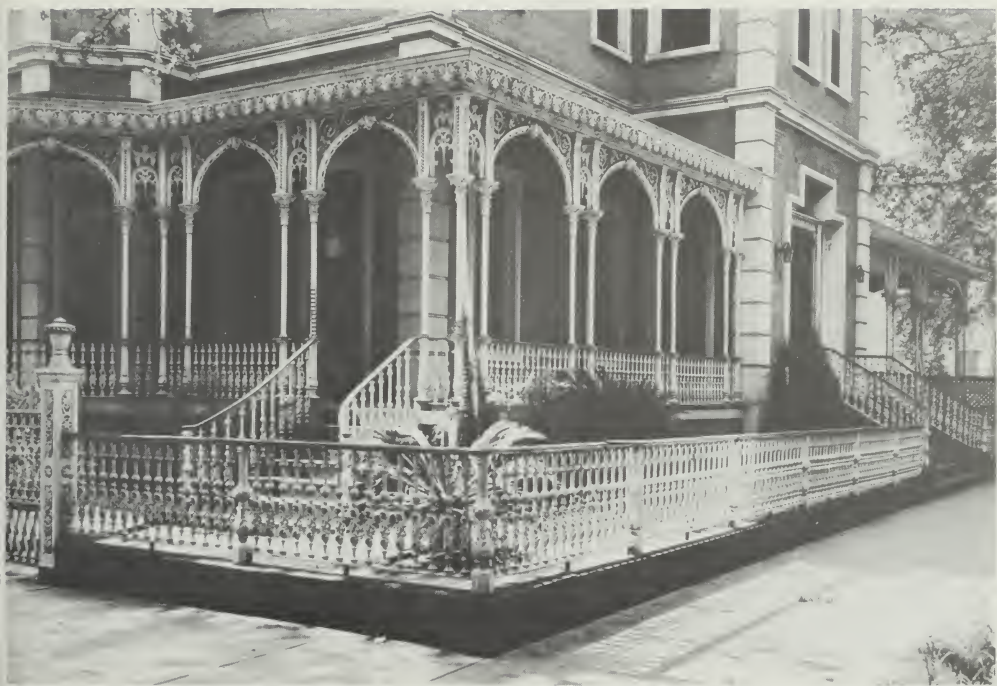
Figure 87. Cast-iron Veranda and Fence, Ketchum Mansion, 400 Government Street, Mobile, Alabama, 1861; Wood and Perot, foundry, Philadelphia. This veranda, skillfully produced in decorative cast iron, as well as the cast-iron railing, fencing, gates, and gate posts, are painted white to contrast with the warm-colored brick of the Italianate mansion. (Jack E. Boucher, NAER)

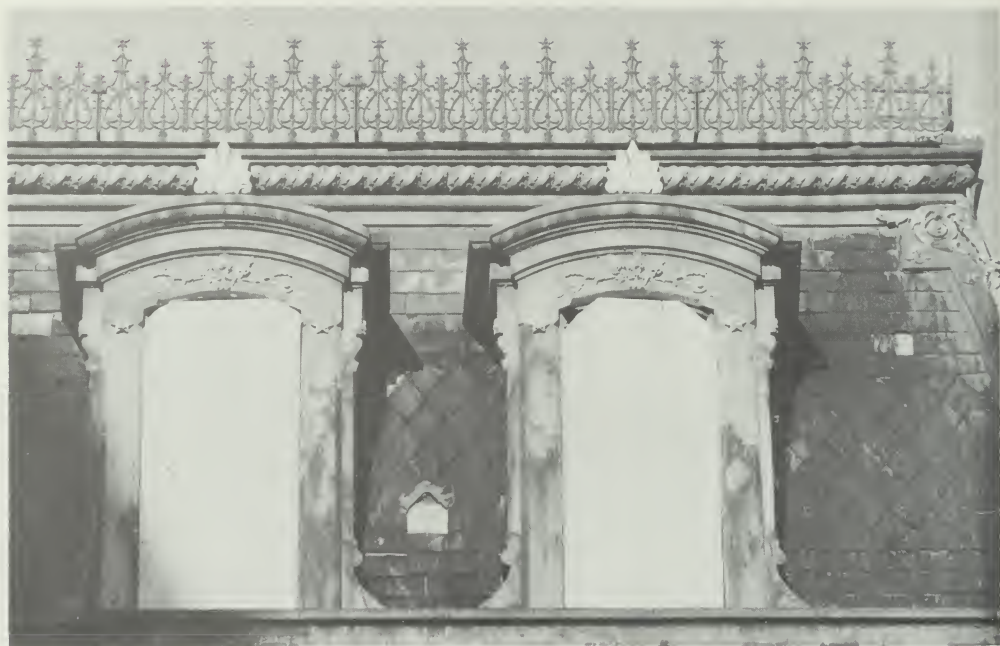
Figure 90. Cast-iron Cresting, Moran-Bogus Building, 501-509 G Street, NW, Washington, D.C., 1889-1890. This slate Mansard roof was added in 1890 by George Bogus, the second owner, to a brick commercial building built the year before by J. E. Moran. Cast-iron cresting was a popular ornamental feature on Gothic Revival and Second Empire style buildings, but can be found on other styles of structures during the Victorian era. Note also the galvanized sheet-iron rope molding and dormers with cast zinc ornament. (David W. Look)

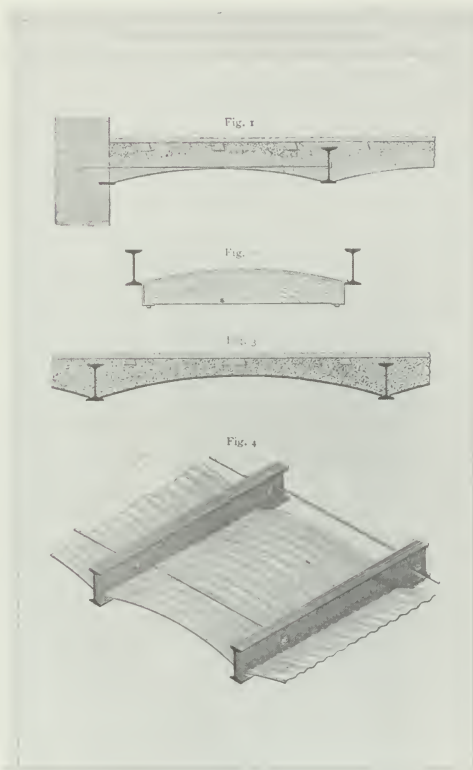
Figure 100. Corrugated Iron Arched Floor Construction Pocket Companion . . . , Carnegie, Phipps and Co., Ltd., Pittsburgh, 1890, p. 43. In an effort to reduce the time needed for arch construction (figures 1 and 2), the corrugated iron arch was introduced (figures 3 and 4) with a concrete fill. The sheets of corrugated iron, bent to a radius, were sprung between the bottom flanges of the I-beams. Note the tie rods between the beams to keep correct spacing and beam alignment. Even though iron is noncombustible, these floors were not "fireproof" because the iron arches and beams lost their strength and collapsed when exposed to the high temperatures of a fire. (Library of Congress)

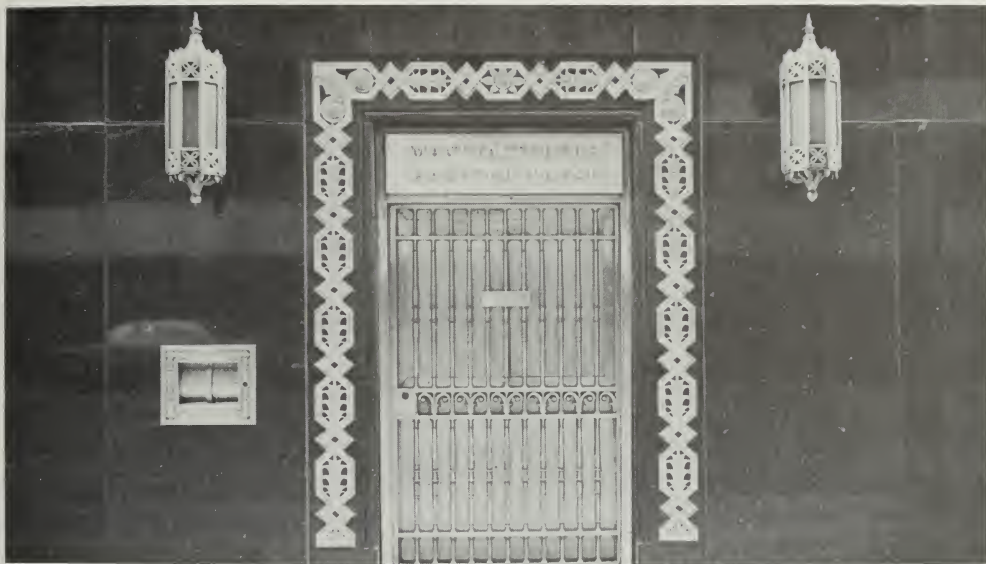
Figure 106. Cast Stainless Steel Entrance, Manufacturers Hanover Trust, Chrysler Building, New York City, 1931; Cooper Alloy Foundry, Elizabeth, New Jersey. The gate, door, frame, lamps, night deposit, and lettering were cast in Nirosta stainless steel. (David W. Look)

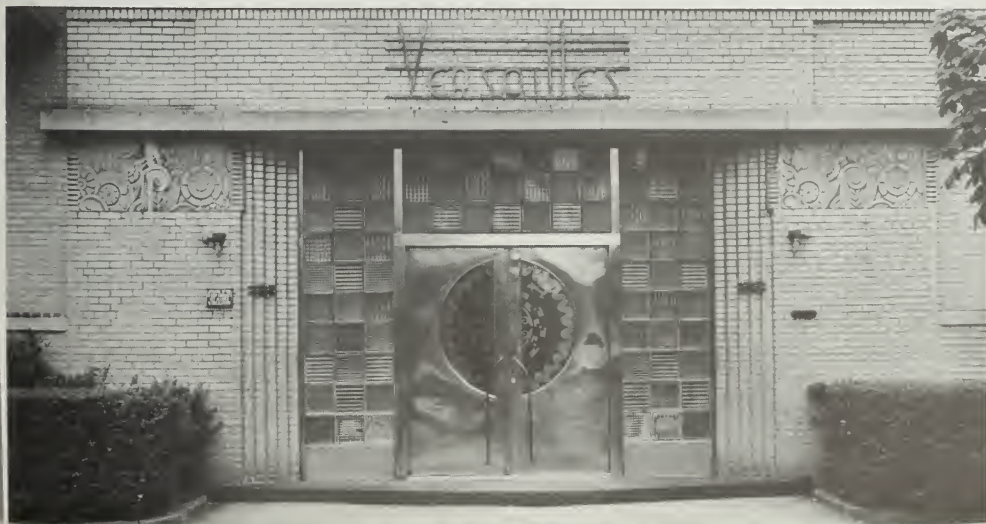
Figure 107. Typical Stainless Steel Doors, Versailles Apartment Building, 1717 Avenue N, Brooklyn, New York, 1936; Kavy and Kavovitt, Inc., architects. The doors were fabricated from sheets of stainless steel with etched and frosted glass in the window. The stainless steel frame was produced from rolled sections and inset with glass blocks. Identical doors with clear glass can be found on the Majestic and Gynwood apartment buildings in Washington, D.C. (David W. Look)

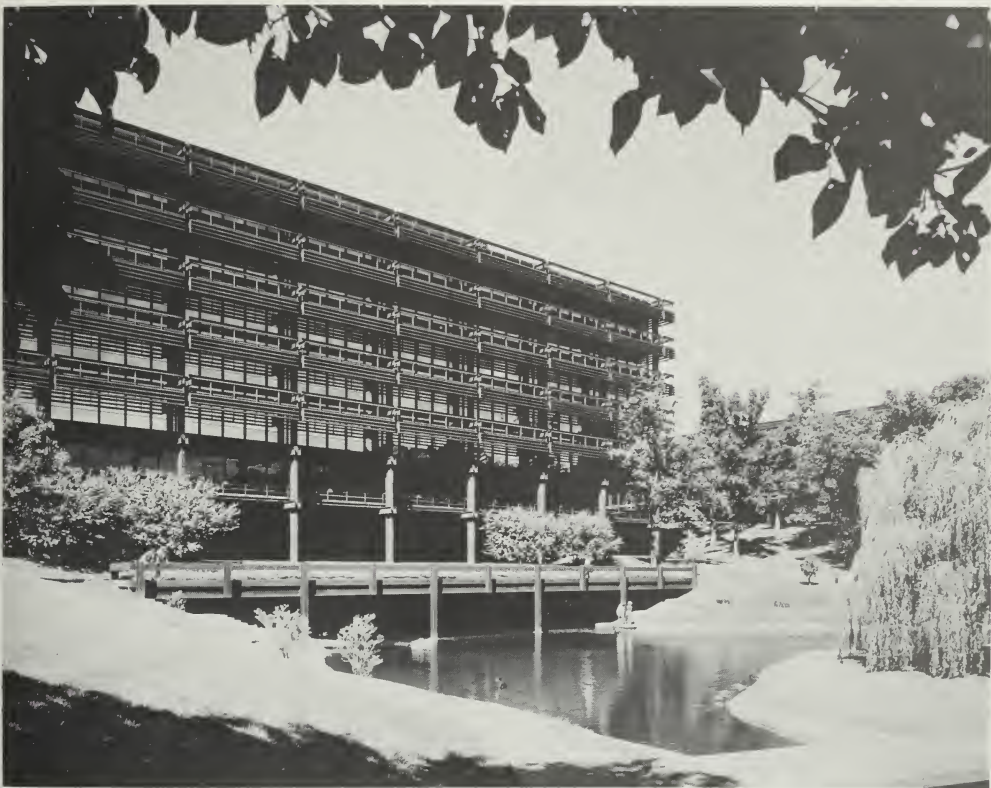
Figure 110. "Corten" Steel, Deere and Company Administrative Center, Moline, Illinois, 1964; Eero Saarinen, architect. *The Deere and Company building, which received many architectural awards, was among the first to make extensive architectural use of this unpainted, corrosion-resistant material for exterior steel members. (Deere and Company)*

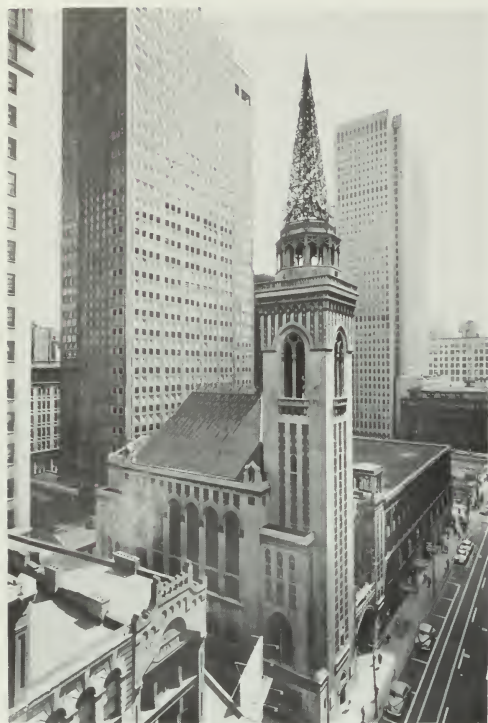
Figure 113. Cast Aluminum Spire, German Evangelical Protestant Church, Pittsburgh, Pennsylvania, 1926; Henry Hornbostel, architect. Also Alcoa Building (background, left), Golden Triangle, 1952; Harrison and Abramovitz, architects. *The perforated spire of the German Evangelical Protestant Church, now the Smithfield Street Congregational Church, consists of 22 filigree aluminum castings. The Alcoa Building is the first multistory structure with an aluminum curtain wall. The other tall building (right) is the United States Steel-Mellon Building. (Carnegie Library of Pittsburgh)*

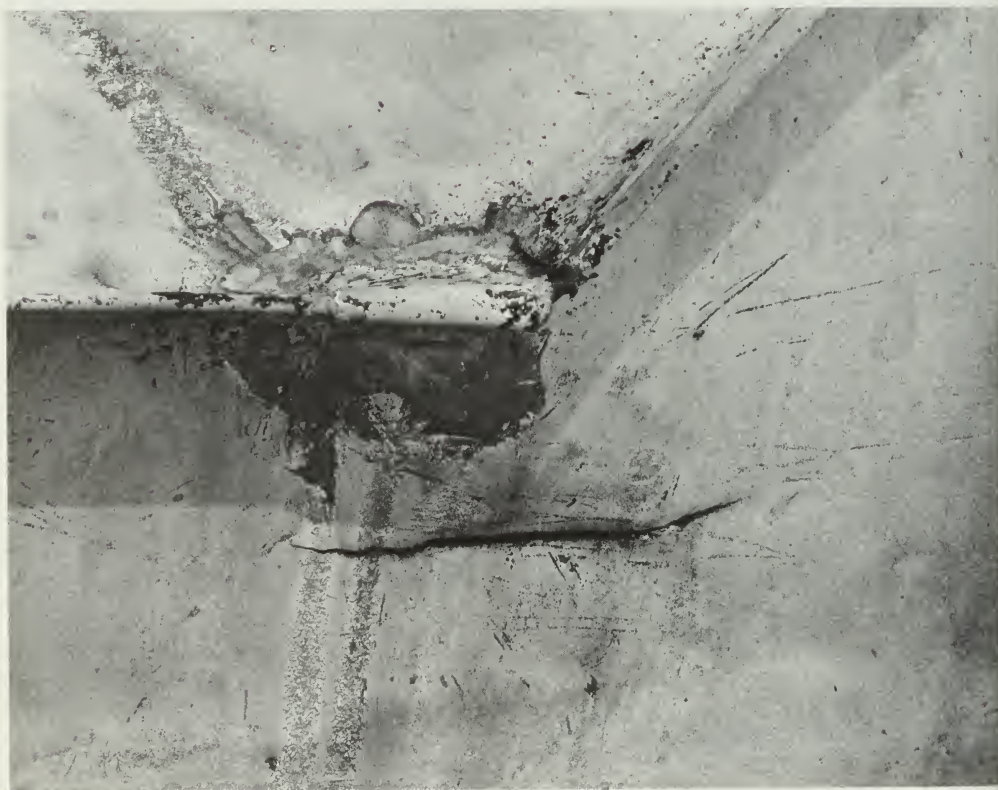
Figure 118. Fatigue Failure. This is an example of fatigue cracking of the copper roof of the Senate House, Kingston, New York. Repeated expansion and contraction due to daily and seasonal temperature changes has caused this sheet-copper roof to crack. Note cracking both at the joint and on the planar surface. (John G. Waite)

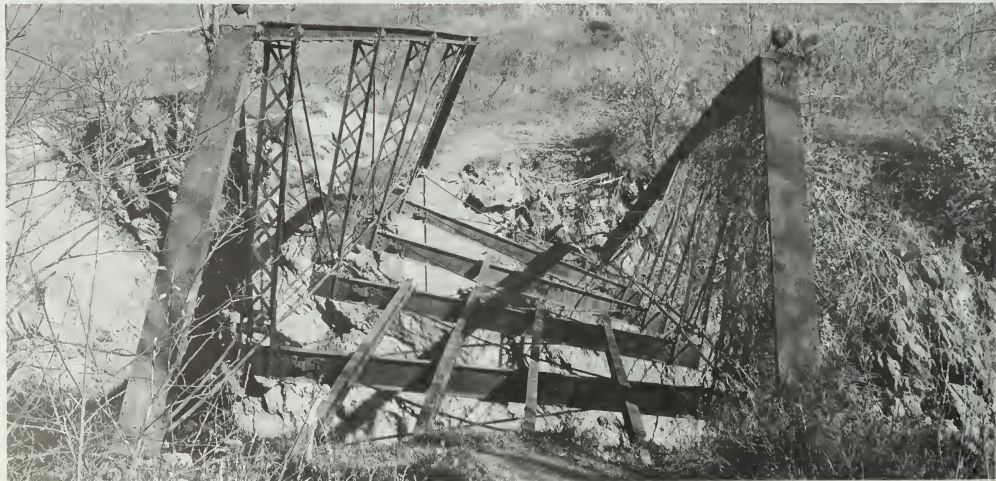
Figure 122. Structural Failure. This 19th-century wrought-iron truss bridge at Brunswick, New York, partially collapsed because the cut-stone abutment supporting it washed away. Once the support was removed, the bridge twisted. (John G. Waite)

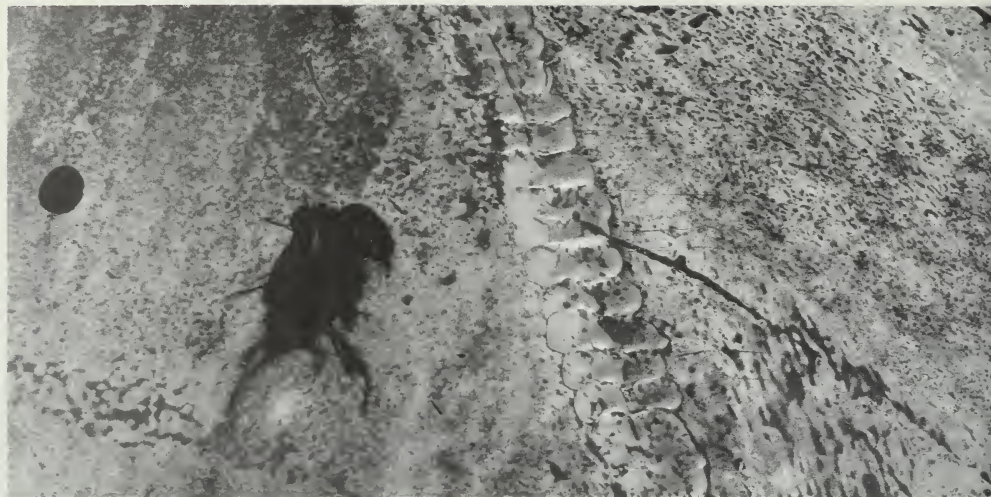
Figure 130. Modern Solder Joint on a Terneplate Roof. Solder was used to make watertight joints at the edges of terneplates on flat-seam roofs. Nineteenth-century soldered joints were almost invisible, that is, the solder was confined to the seam. These wide-soldered joints are on the Old Pension Building in Washington, D.C. The problems with wide-soldered joints are: (1) they facilitate galvanic corrosion because they provide a wider surface area with which the plates can react, and (2) they tend to fail because of the different coefficients of expansion and contraction of the solder and the terneplate. The black spots to the right of the solder are asphalt or a bituminous roof patching compound, which may cause deterioration of the terneplate and should be removed. (David W. Look)

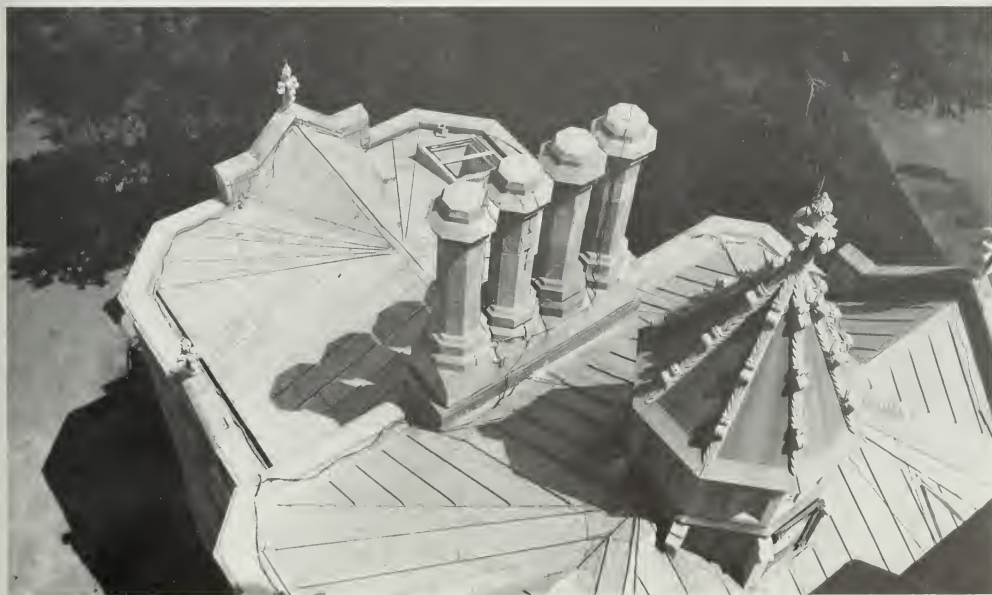
Figure 135. Complete Substitution of Lead-Coated Copper Roofing for Terneplate Roofing. The 1864 wing addition of Lyndhurst, Tarrytown, New York, originally had a terneplate roof. In an attempt to find a more permanent roofing material, a lead-coated copper roof was substituted for the terneplate, duplicating the pattern and sheet sizes of the original roof. In such substitutions, details may have to be redesigned because of differences in expansion and contraction rates and differences in workability of the material. The color of lead-coated copper is not the same as terneplate because terneplate roofing was never left unpainted. Therefore, lead-coated copper roofing substituted for terneplate should also be painted if it seen from normal viewing angles (usually from street level). (John G. Waite)

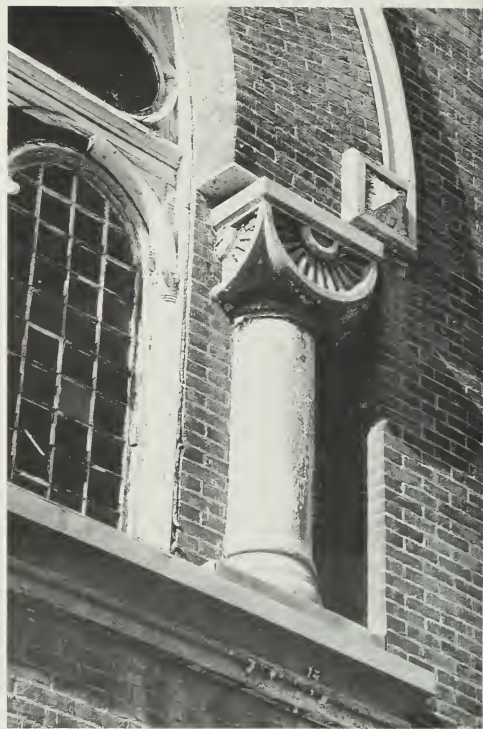
Figure 138. Zinc Deterioration and Staining. On the First Presbyterian Church in Alexandria, Virginia, the engaged columns, arch molding, corner blocks, and the sill molding are fabricated of cast zinc and galvanized sheet iron (the windows and frames are wood). The paint has deteriorated, leaving the surface of the metal bare in some places. The zinc or zinc coating on iron has oxidized. Notice the whitish corrosion stain on the brick from the zinc carbonate coating which continues to wash over the surface of the bare metal and then down over the bricks. The metalwork should be scraped down to remove all loose zinc carbonate. Joints should be caulked and/or resoldered, and repainted with a zinc chromate primer. (Baird M. Smith)

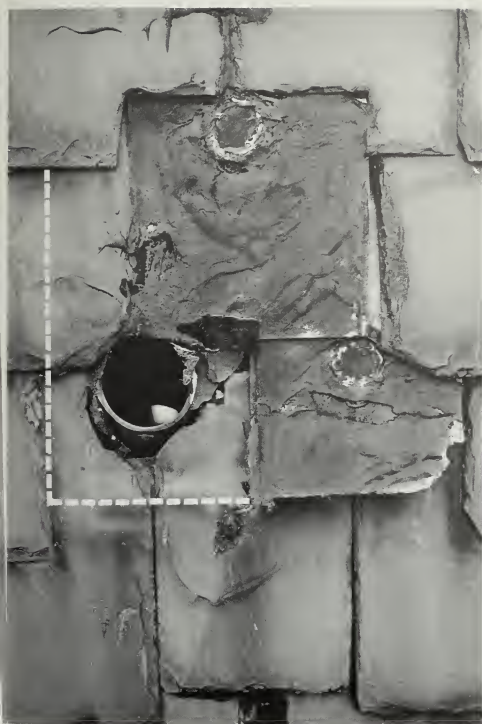
Figure 139. Zinc Corrosion, Erosion, and Inappropriate Repairs. In construction of the Nott Memorial at Union College in Schenectady, New York, during the 1870s, architect Edward Tuckerman Potter used "illuminators" in the ornamental slate roof. These were slate-sized zinc plates with a small colored-glass disc 1 3/4 inches in diameter inserted in the center. Barely discernible from the outside, they transformed the vaulted dome within a "heaven" of red, yellow, purple, orange, and green stars. Shown here is a cluster of three illuminators, each consisting of a zinc plate with a small colored-glass insert and the connecting tube through the metal deck and plaster to the interior. The zinc was inaccessible and not kept painted. Small fragments of slate broke off and tumbled down with gravity. The wind and rain eroded away the layer of corrosion from the zinc surface. The left plate is missing (see dotted line), showing the connecting tube. The corner of the lower right plate is missing because it became brittle and fractured off. Unfortunately, modern roofing cement applied over the zinc plates is accelerating the deterioration. (John I. Mesick, *The Nott Memorial: A Historic Structure Report* Schenectady, New York: Union College, 1973, p. 65)

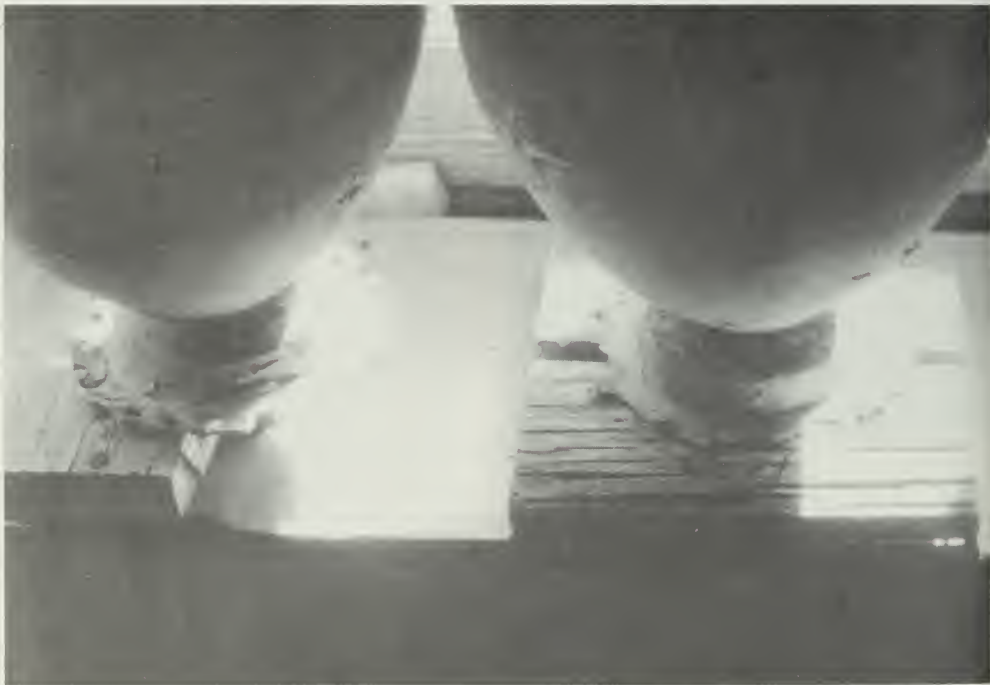
Figure 140. Galvanic Deterioration. Bases of zinc vases from the roof balustrade of Lorenzo, Casenovia, New York, have deteriorated because of the electrolytic action between the zinc and the machine-cut iron nails used to fasten the vases to the balustrade. The zinc was sacrificed in favor of the iron because the iron is more noble than the zinc. (Douglas Clinton)

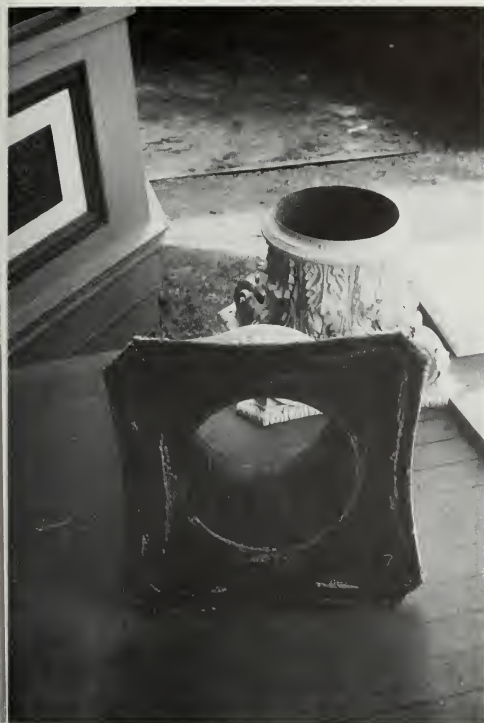
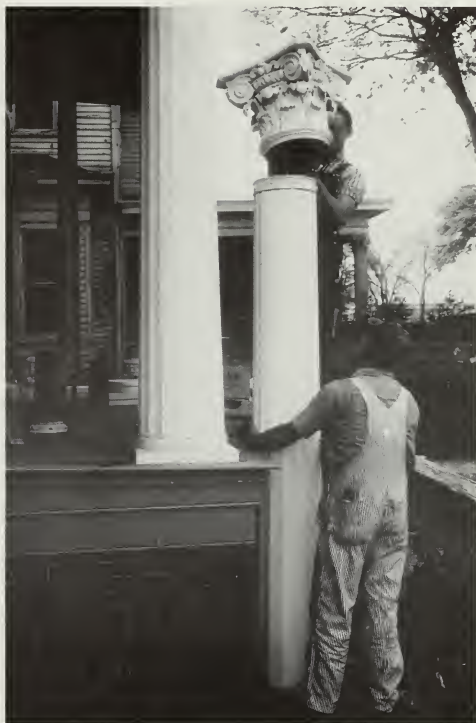
Figure 141. Repair of Galvanized Sheet Metal Capitals. (a) Fabricated for the 1890 Bullard-Hart House, Columbus, Georgia, these Corinthian capitals were originally assembled from many pieces of pressed sheet metal, which were soldered together to form the acanthus leaves. (b) The capitals were in salvageable condition and were taken to a sheet-metal shop where they were cleaned. Loose pieces were resoldered and caulked; missing pieces were replaced with new stamped pieces; and the completed capitals were repainted. The deteriorated wooden column shafts were repaired and repainted. The restored capitals were refitted onto the shafts and the entire columns were then returned to their original positions. (Thomas Taylor)

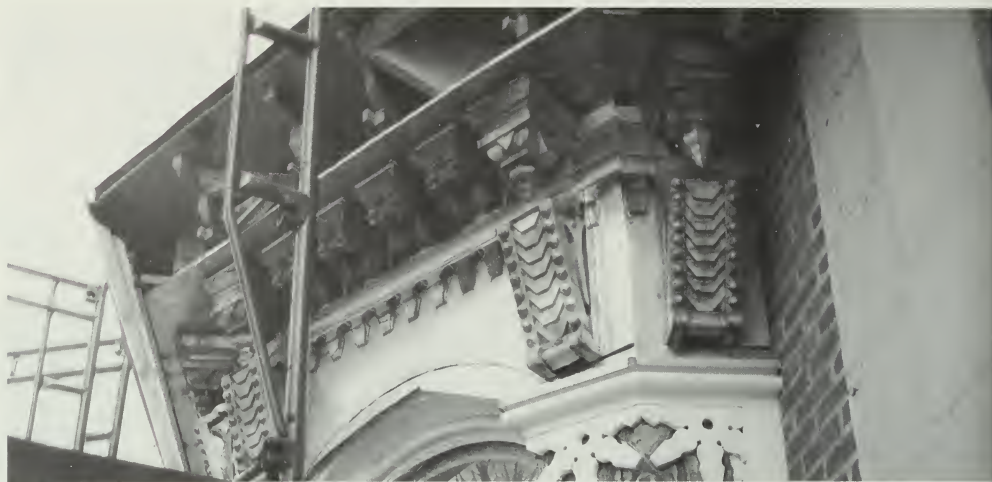
Figure 142. Restoration of Galvanized Sheet Iron and Cast-Zinc Cornice. This is the upper third of a wooden bay window on a Second Empire brick rowhouse in the Logan Circle Historic District of Washington, D.C. (a) From the window down, the bay is wood and glass. The roof of the bay had leaked for years and the wooden roof rafter and projecting supports for the cornice had rotted. The bay window was carefully disassembled and rebuilt replacing all deteriorated lumber. The surviving pieces of galvanized sheet-iron and cast-zinc cornice were taken to a sheet-metal shop. The pieces that were repairable were cleaned; missing portions of brackets on the right were replicated of galvanized sheet iron using the originals as a model. (b) On the opposite side of the bay, all of the brackets and modillions are repaired originals but all of the flat and molded sections are new 26-gauge galvanized steel. The 65-year-old sheet-metal worker on this job said that the only two major advances in metal cornices in his lifetime are the use of pop rivets for fasteners (used also in leatherwork) and the use of autobody putty to patch holes, mold small missing details, and waterproof joints. The putty dries hard and can be sanded. (David W. Look)
